## Recent Circuit Breaker Fire &

At approximately 9:00 PM on the evening of Sunday, February 11, 2018, a violent explosion occurred at the Monacillos Transmission Center (“MTC”) when a 115 thousand-volt (“kV”) Oil Circuit Breaker (“OCB”) ruptured. The MTC is located southeast of the city of San Juan (see Figure 1). The OCB that exploded was a General Electric unit that was installed in 1975, with over forty years of service. It was extremely fortunate that the explosion occurred at a time when no personnel were present, and there were no resulting injuries.

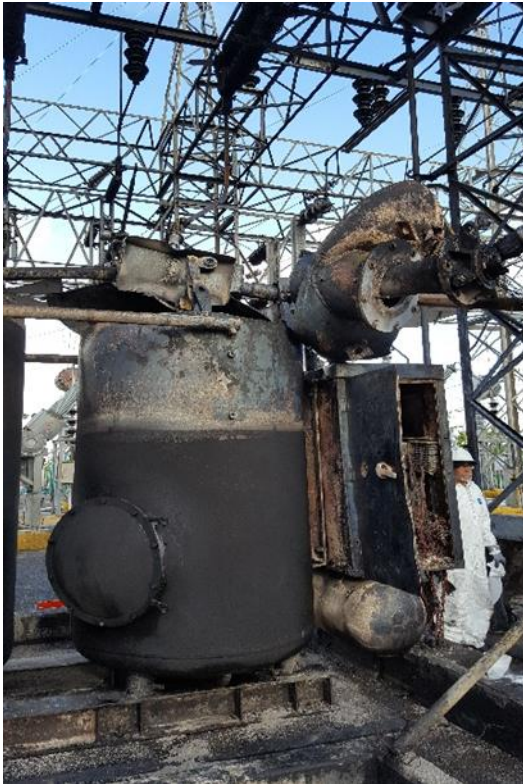
Figure 2: Breaker Post Explosion

While OCBs are reliable and low-cost units, the dielectric strength (the ability to prevent arcing and electrical conduction) of the oil tends to weaken over time due to age, contamination by gases, and introduction of carbon particles which are produced when the breaker operates. Another consideration with OCBs is that the oil is flammable, and when dielectric strength becomes too weak, an explosion like the Monacillos event can occur.

As can be seen from the pictures above, internal failure of an OCB can be catastrophic and dangerous not only to life and limb of personnel that might be in the area, but also to buildings and structures in proximity to the breaker failure.

The ruptured OCB is being replaced by a SF6 (sulfur hexafluoride) breaker at a cost of approximately \$100,000, with an estimated repair time of eight days. A SF6 breaker represents a newer technology than the OCB technology.
